## *Field Test Results*

### **ENERGY HOME-SHIELD**

### *Radiant Barrier System*

On June 12<sup>th</sup> thru 18<sup>th</sup> 2001, a survey was conducted at a facility located in Lakeland Florida in accordance with the State of Florida Energy Office / ENERGY CONSERVATION ASSISTANCE PROGRAMS Designation: **ECAP-CUL-1-99**

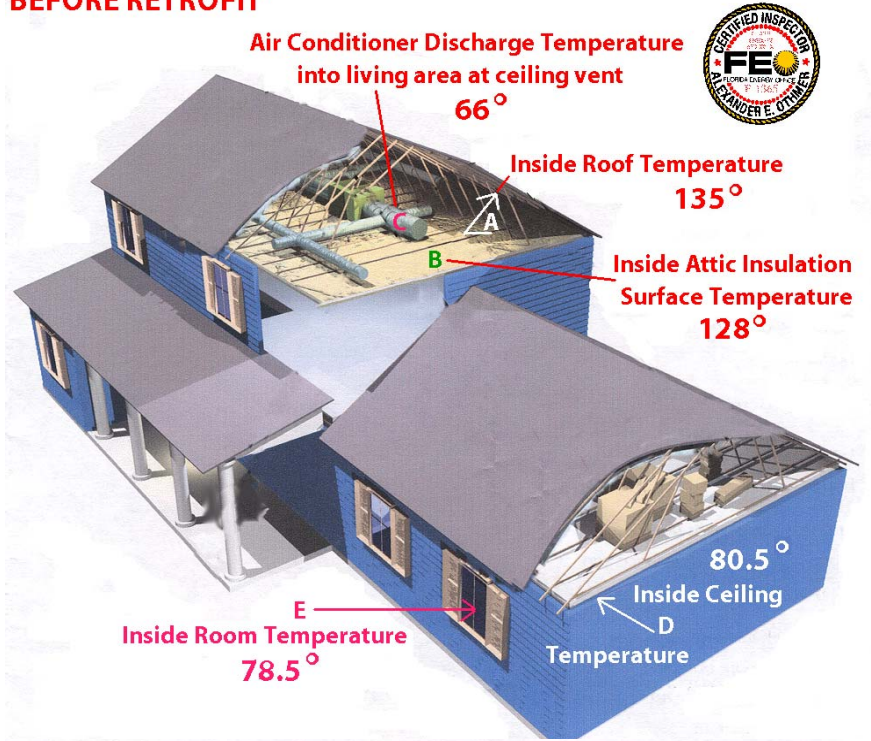
**BEFORE RETROFIT**

The illustrations below show a synopsis of our findings;

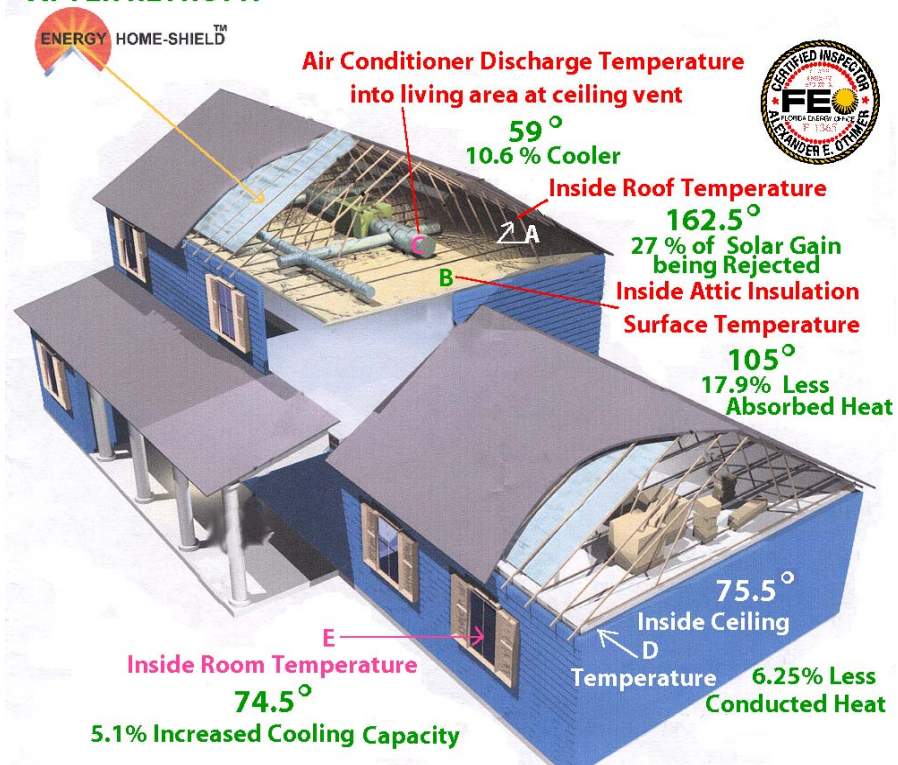
**AFTER RETROFIT**

- Our survey indicated that the *Total, Roofing System, Solar Heat Loads* on the structure tested were being significantly reduced by **27% during day light hours**, by the use of your **ENERGY HOME-SHIELD Radiant Barrier System** as a **Energy Conservation Measure (ECM)**.
- *This is being accomplished with no negative effect on the existing buildings Architectural Aesthetics or water tight integrity, and is also reducing Solar Gain related air conditioning cost.*

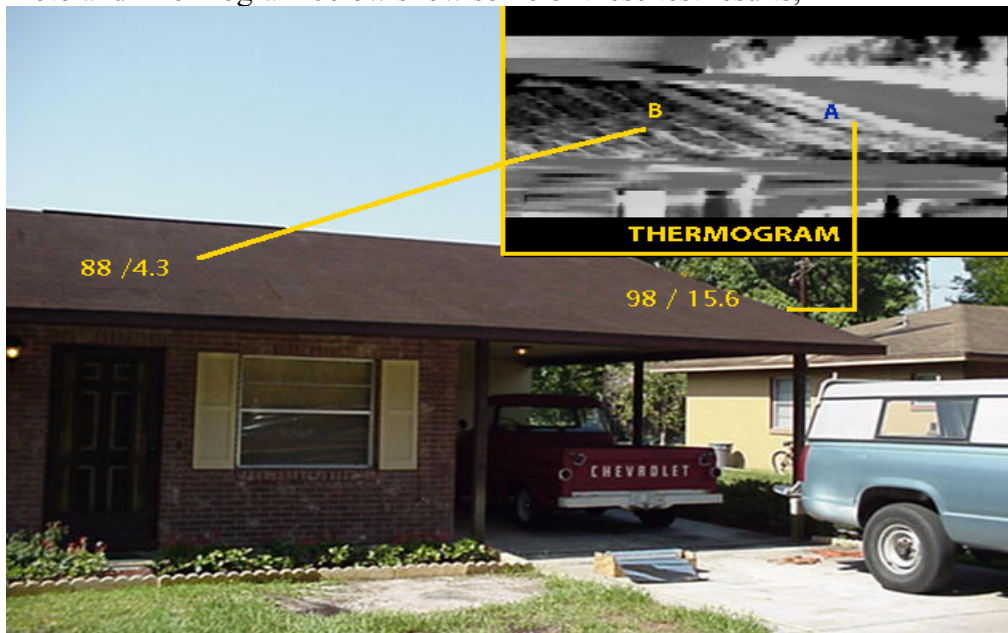
The Photo and Thermogram below show some of these test results;

The lighter areas in the Thermogram indicate Heat while the darker areas indicate cooler temperatures.

Area ( B ) in the Photo and Thermogram show the roofing system loosing conditioned air from inside the house ( roof surface temperature of 88 degrees ). ***This area had not been retrofitted*** with the *ENERGY HOME-SHIELD Radiant Barrier System* .

Area ( A ) shows a section of the roof ***that had the ENERGY HOME-SHIELD Radiant Barrier System*** installed. You can clearly see the amount of heat being Rejected ( white areas ) and the higher surface temperature ( 98 Degrees ).

In this instance, that is ***10 Degrees less heat*** that the air conditioner system has to contend with.

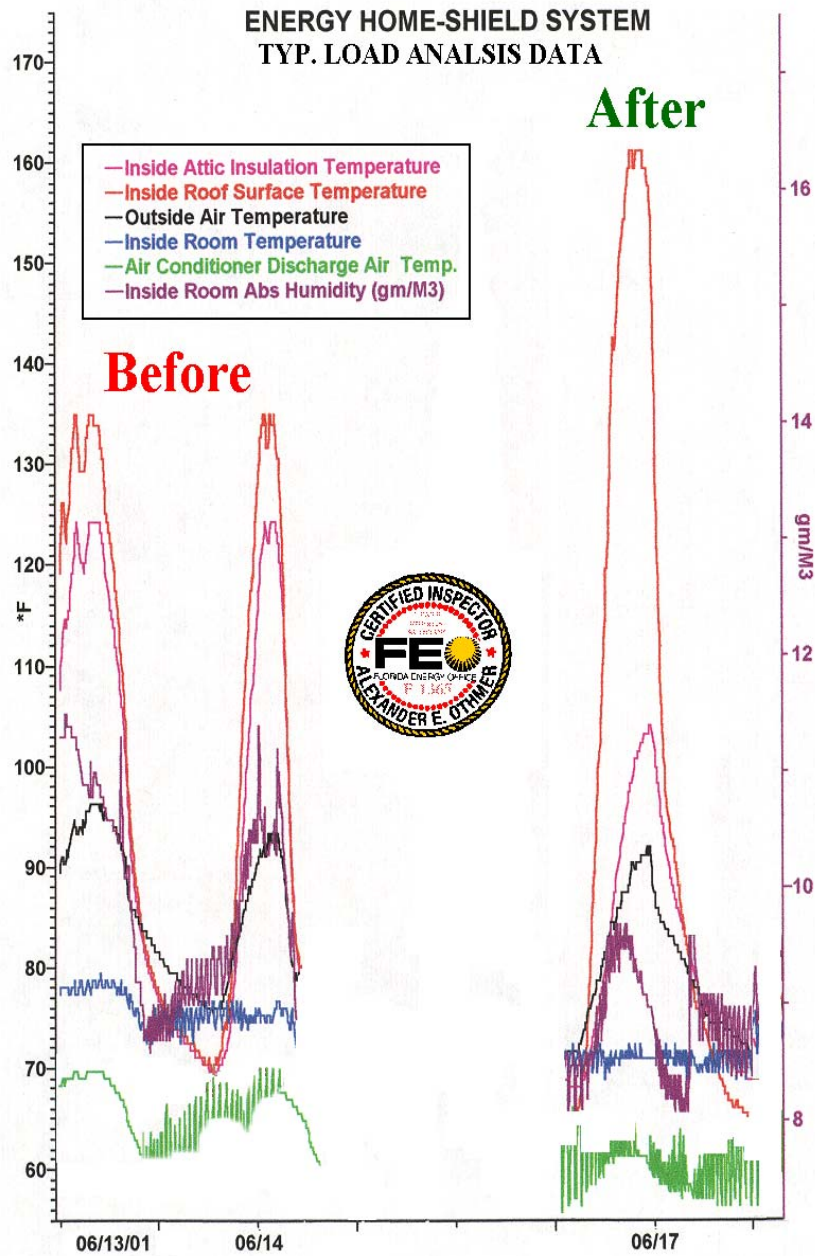
In all 1,444 Data Points were recorded over a 120 hour period, the chart below shows a synopsis of the type of data collected;

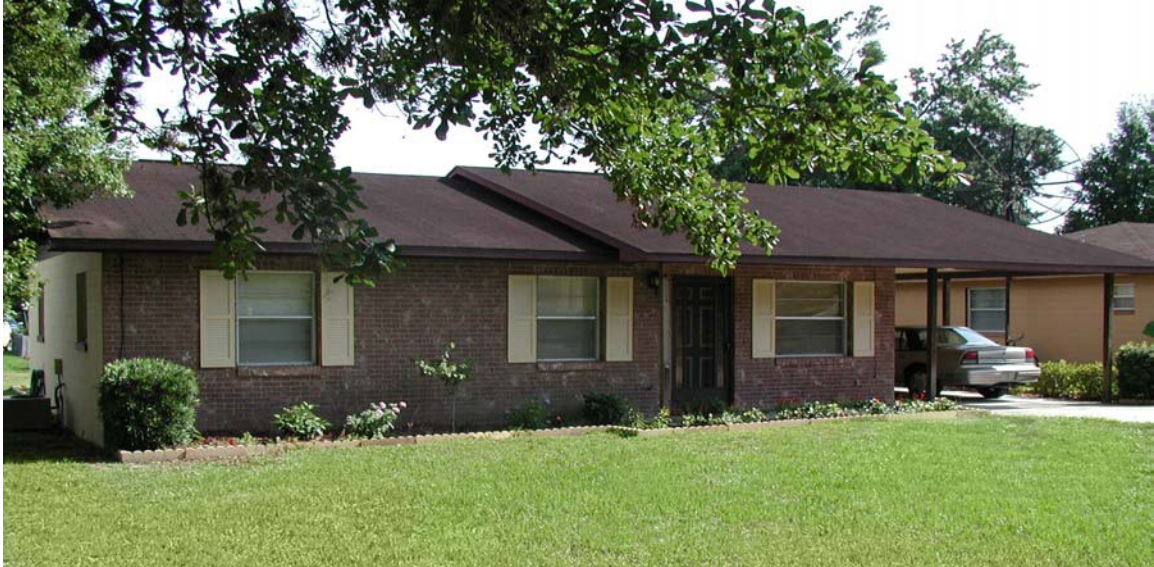
The facility was a 19 year old, standard constructed Concrete Block, 1,100 Square Foot, Single Story Residential Home with a standard wood and shingle roofing system.

The roofing system faced **North West and South East** at a Longitude of 81 Degrees 56 Minutes and a Latitude of 28 Degrees 04 Minutes. The photo below shows the actual structure from the North East side.

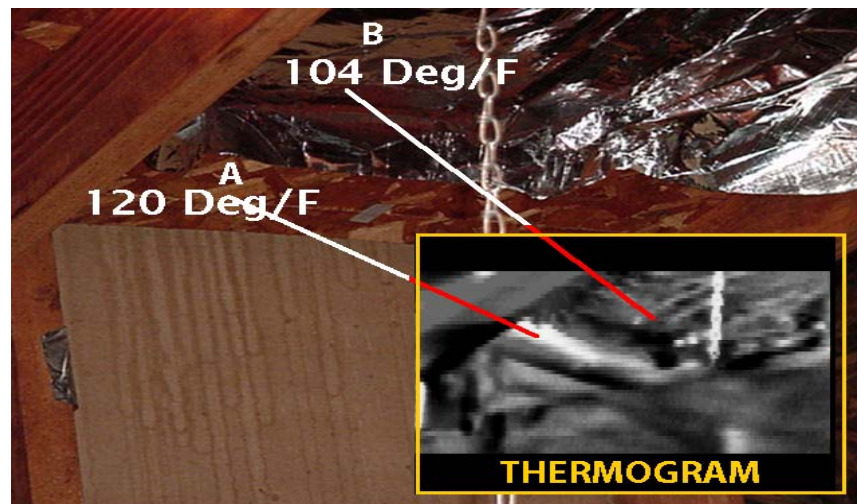
As tested the system was installed at 3.50 inches below the inside roof surface area. The photo and Thermogram below show some of the typical properties of the system;

Area ( A ) shows the inside roof surface temperature prior to being covered with the ***ENERGY HOME-SHIELD Radiant Barrier System***, area ( B ) shows the resulting THERMAL REJECTION that the retrofitted areas are providing.
